Manhole Inspection Summary

Manhole # S35QQ_006MH

Insp Date: **1/22/07 10:16 AM**

Location Address: **2503 SAINT PAUL ST**

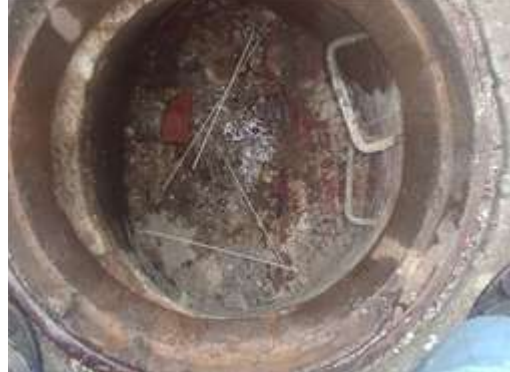
Top View

Frame Offset: **1** (in.) Condition: ☐ Sound ☐ Cracked ☒ **Leaks**

Channel Material: **Brick** ☐ Parged ☒ **Debris** (not Condition related)

Frame offset. Channel debris.

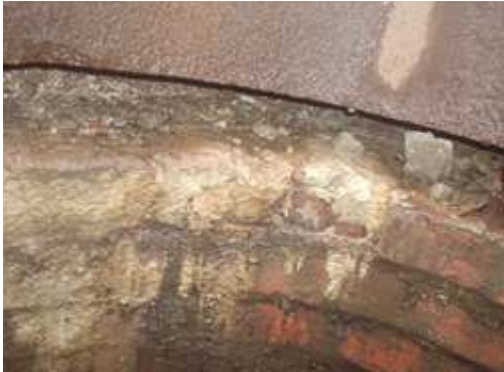
Defect

Condition: ☐ Sound ☐ Cracked ☐ Root Intrusion ☐ Loose Brick ☒ **Deteriorated**

Infiltration: ☐ None ☒ **Joint** ☐ Cracks ☐ Mortar ☐ Roots ☒ **Wall**

Frame leaks. Adjustment deterioration and infiltration.

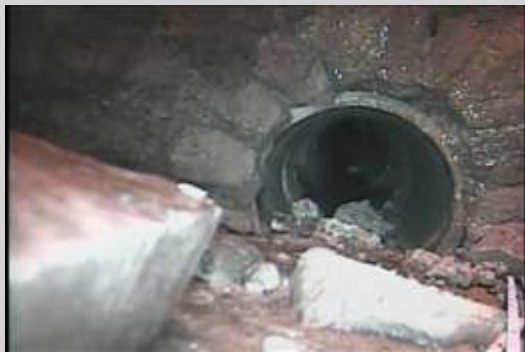
8 in. Circular Gravity Sewer
Pipe Out @ 12 O'Clock

Comments **The Barrel has active infiltration.**

Infiltration: ☐ None ☐ Joint ☐ Cracks ☐ Mortar ☐ Roots ☒ **Wall**

Barrel infiltration (Active).
